STS-102 FLIGHT READINESS REVIEW

February 27, 2001

Orbiter

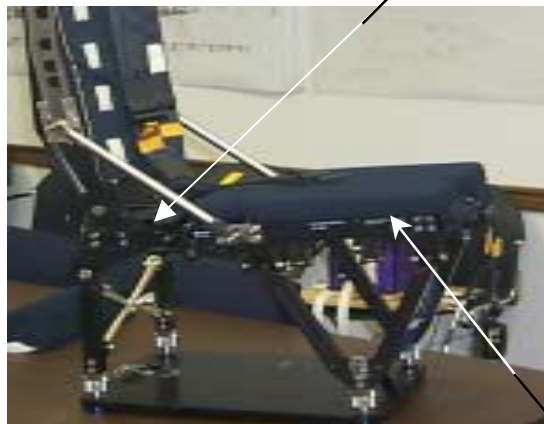
- Eliminates Vehicle/Crew Safety Concerns
(Potential Inability To Reach Flight Controls If Seat
Back Cannot Be Repositioned For Entry)
- Seat Back Angle Control Lever Moved From Right Rear
To Right Front
- Inertia Reel Control Lever Moved From Right Front To
Left Front
- Now Identical To LW CDR/PLT Seats (& HW Seats)

New Configuration
Both Control Levers
Easily Accessed At Front Corners

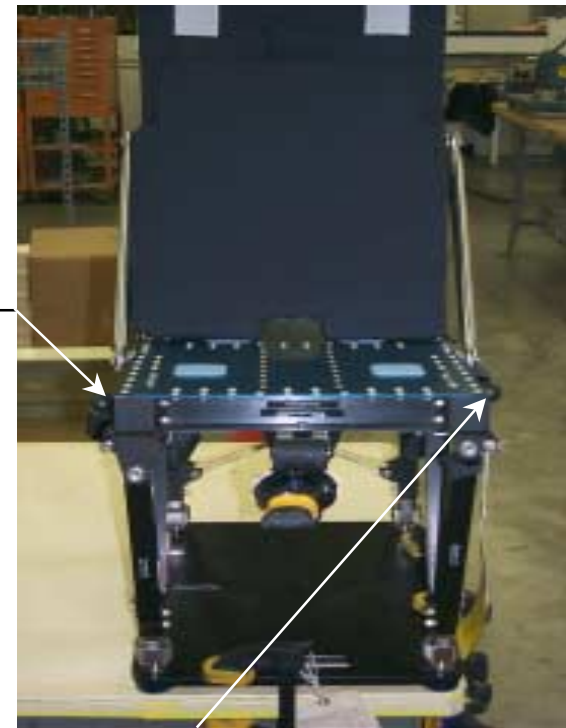
Old Configuration
Seat Back Control Was Difficult To Reach

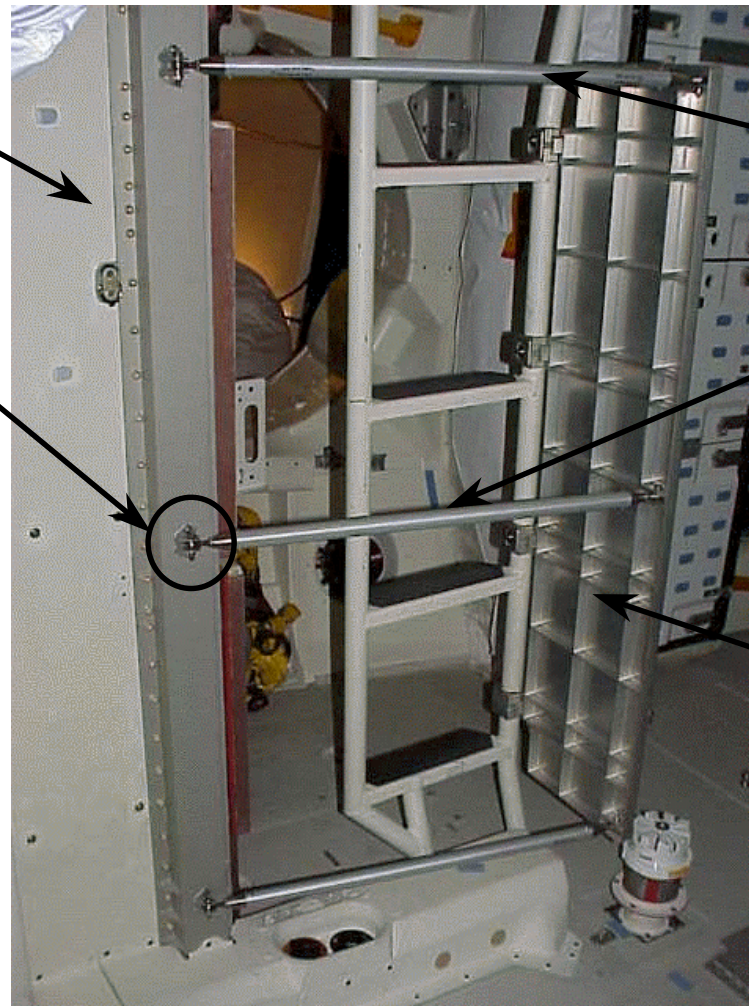
Emergency Egress
Platform

Fasteners at each
of the strut attach
points replaced by
pip pins

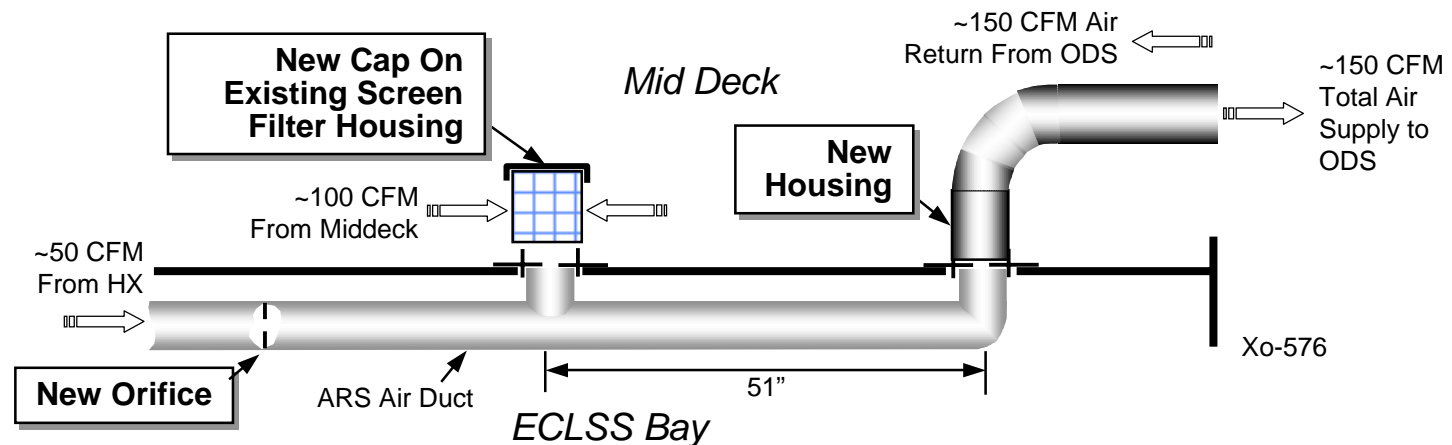
Shuttle ARS Ducting Below the Floor:

- Previously OV-103 has flown an extended mid-deck floor to external airlock ARS duct configuration for improved ISS/Spacehab air quality
 - Crew installed duct was 51 inches longer and was routed above-the-floor to the forward mid-deck venturi location
- New (permanent) modification provides rerouted air flow below the mid-deck floor
 - Allows returning to the previously manifested shorter duct and connection to the aft venturi location
